Soil Burial Tests:

Effect of Soil Burial Exposure on the Properties of Rubber, Crosslinked Polyethylene, and Vulcanized Wire Coatings

By G. H. BEBBINGTON

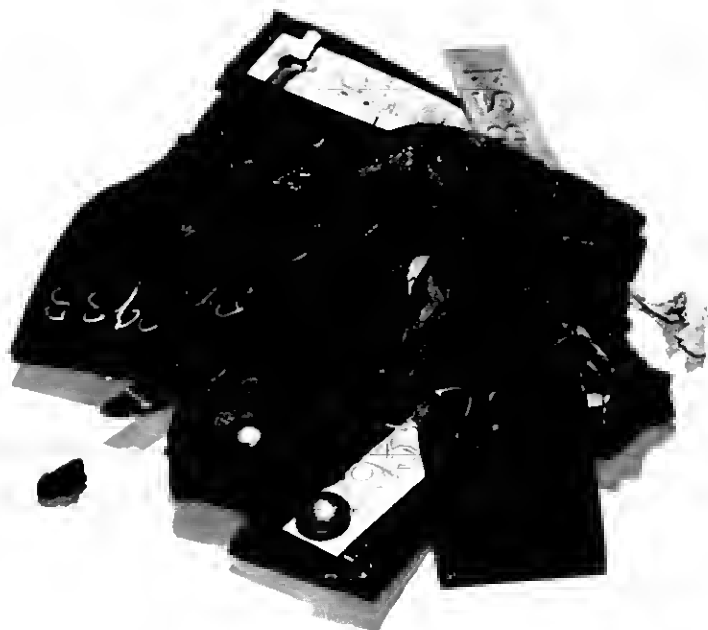
Fig. 10—A mixed pile of tested specimens of #293 polyester urethane from four years shelf-aging and four years burial at Roswell which have been in storage together for five years. Generally, the buried specimens were brittle and the shelf-aged were tacky, but where they have been in contact with each other, the shelf-aged controls were found to have liquified.

Figure 10 displays one more phenomenon involving the ester polyurethane sample that has occurred in the exposure test. The remains

of the four-year shelf-aged control specimens and those that were retrieved after four years burial at Roswell were stored together after they had been tested. When examined after five years of storage, the burial specimens were found to be brittle and the controls to be tacky. But wherever they had been in contact with each other, the controls had liquified as is illustrated by the shiny wet areas in the photograph. In this same period of time, the remaining untested control specimens in this experiment are also getting moist and approaching this liquid state without contact with any other specimens.

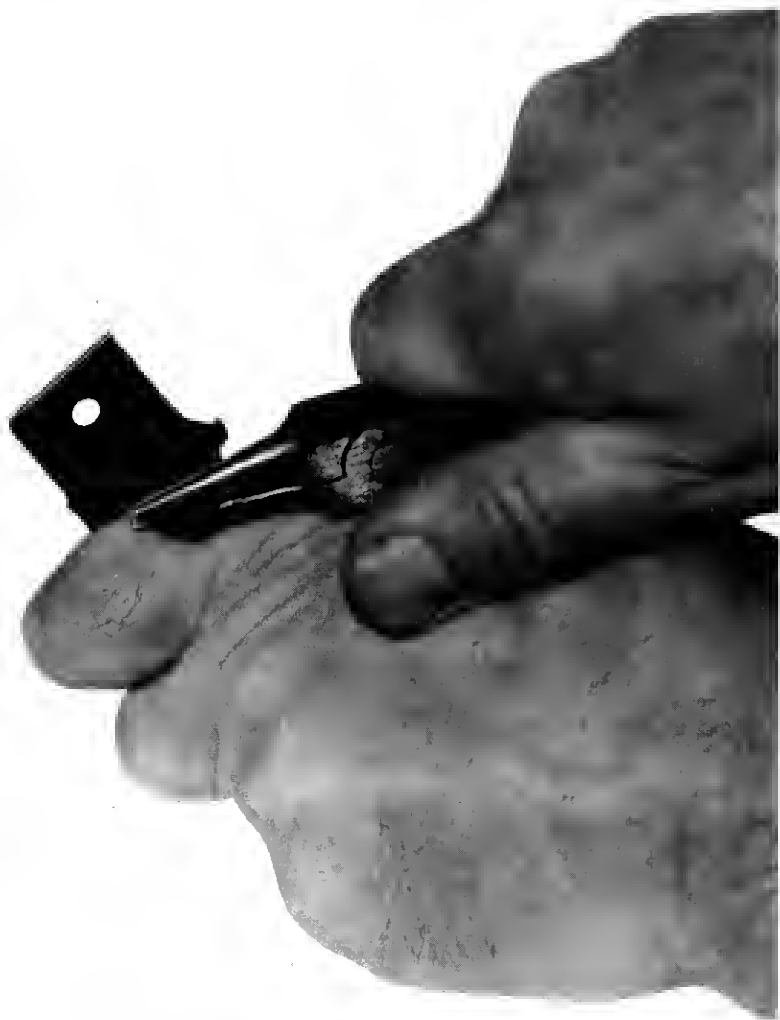
Figure 11 illustrates the comparative pull test used in this program. If the bond is weak, an adhesion failure occurs and no rubber is left on the metal. If the rubber is weak, a cohesion failure occurs and it tears leaving a major portion of the rubber adhering to the metal. Strong bonds and strong rubbers are very difficult to pull apart.

Fig. 11—Hand-peel test used to determine the strength of rubber-to-metal bond. Specimen is #275-SBR compound M-206 bonded to stainless steel with the Chemlok 201 plus Chemlok 220 system—after retrieval from Bainbridge.
